Master Facility Plan  
Update

FUNCTIONAL  
TEAM  
REPORT

## Central High School

## South High School

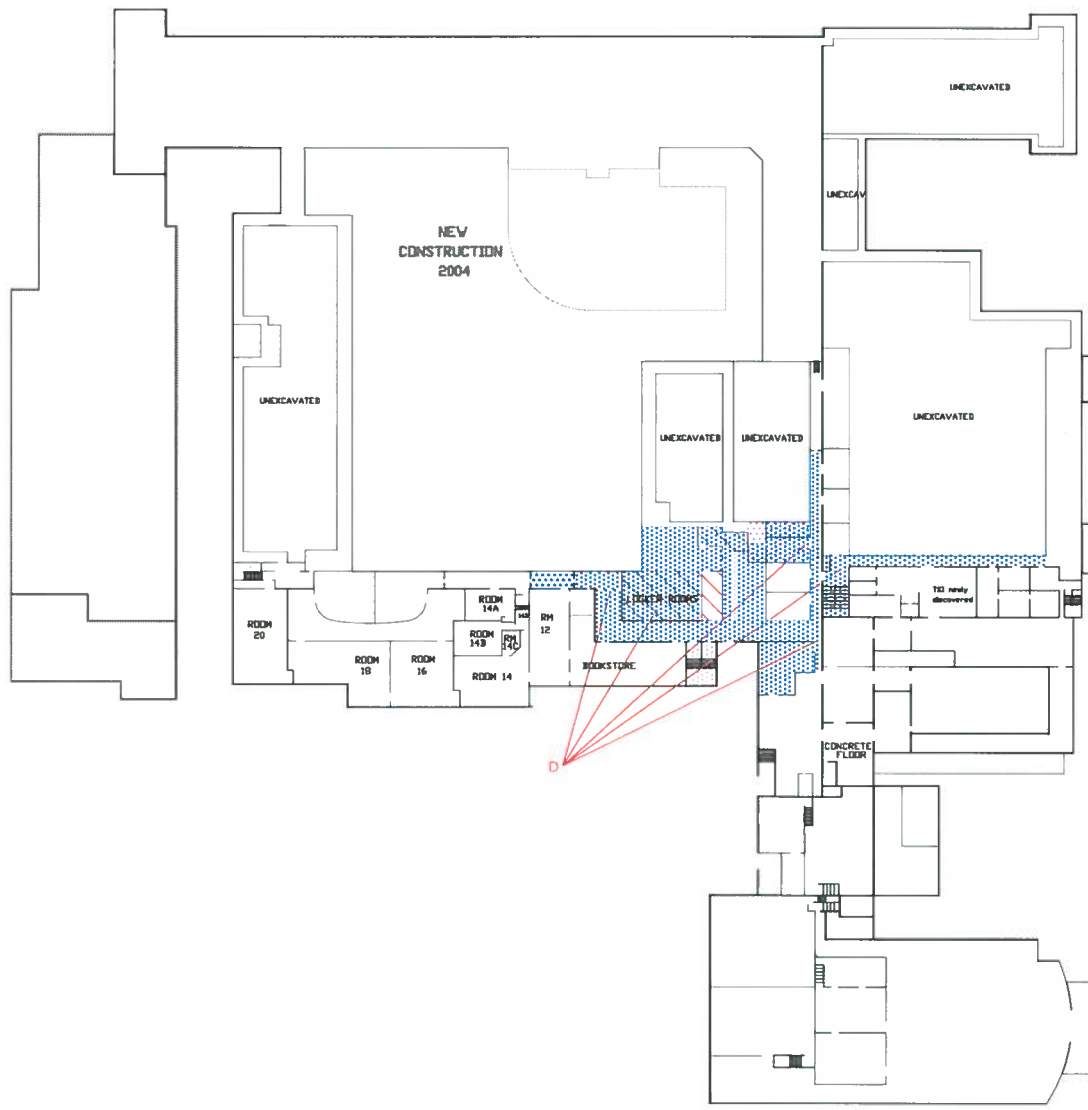
Estimate: (under development)
10. **Asbestos Floor Tile** - An asbestos abatement plan was in place up until +/- two years ago. This plan needs to be reinstated. Approximately 100,000 square feet of asbestos containing flooring remains throughout the building, along with approximately 15,000 square feet of thermal system insulation. See the Appendix for locations;

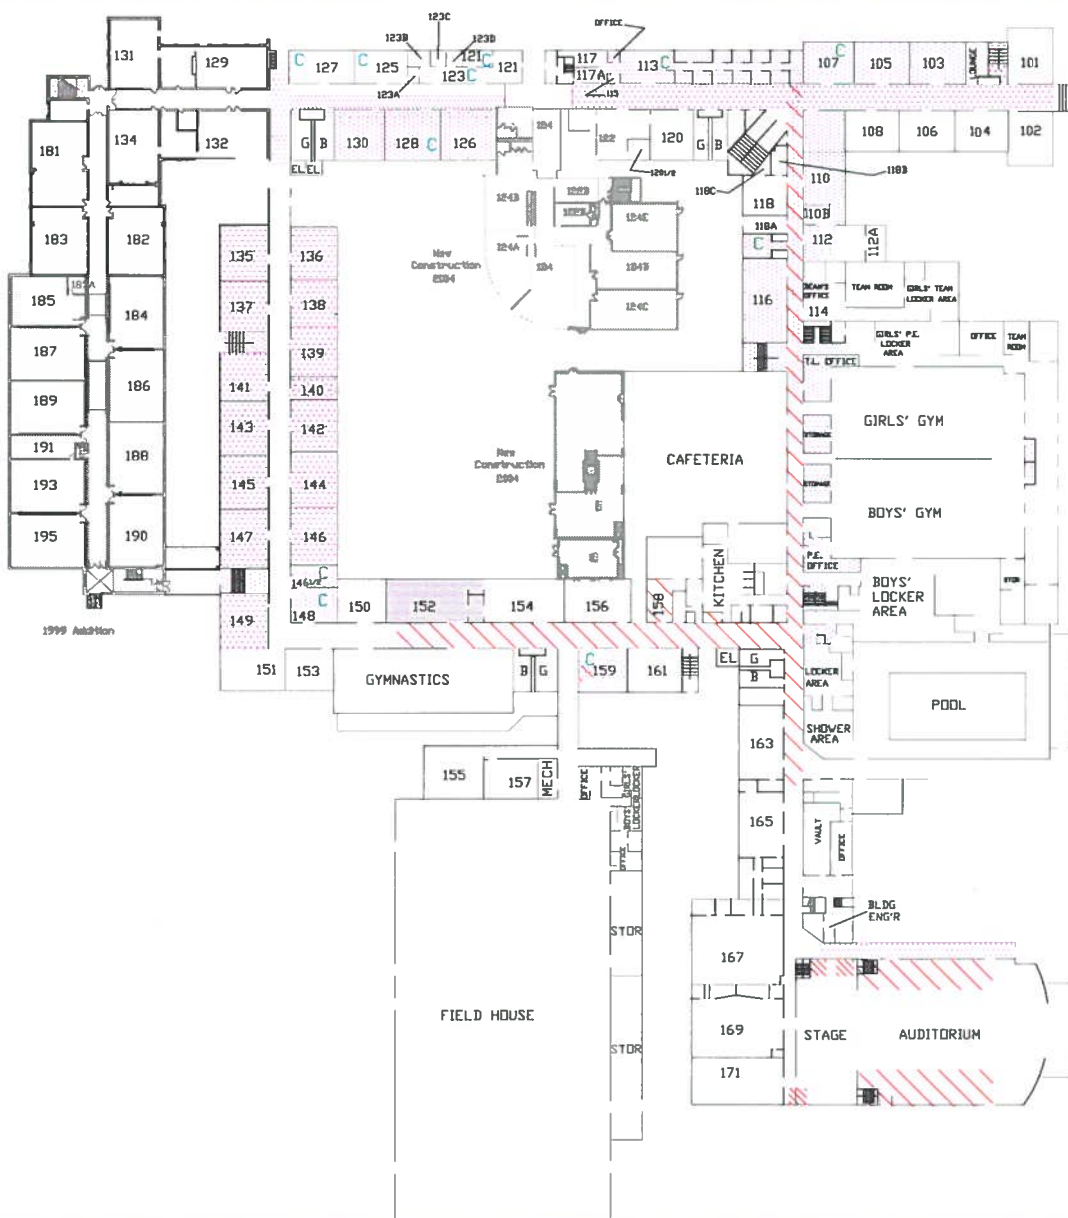
DAMAGED ACM
- NOTE: TSI IN SOME WASHROOM PIPE CHASES

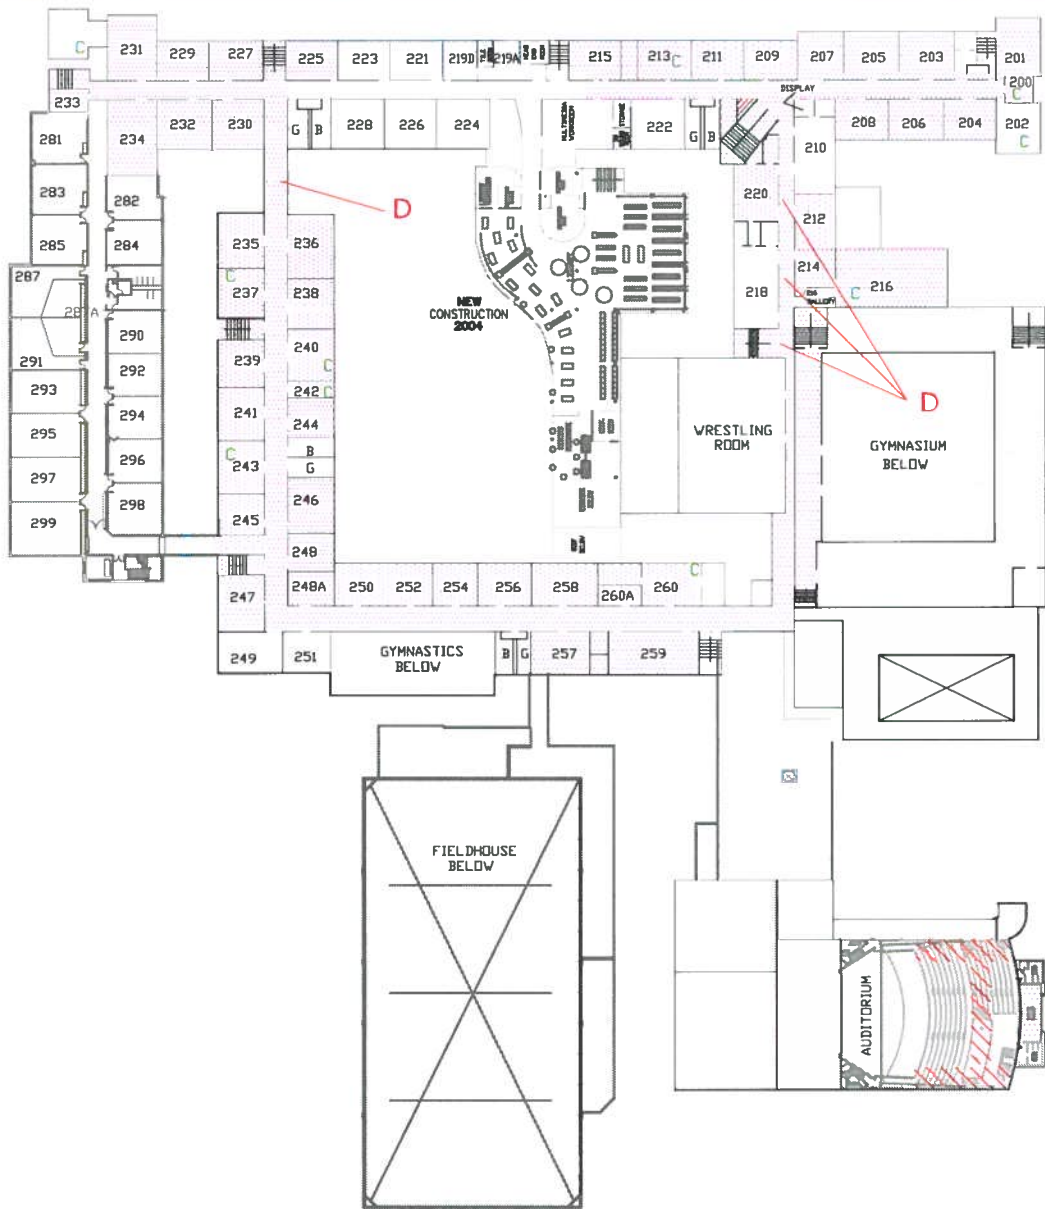
**HINSDALE CENTRAL HIGH SCHOOL**  
 SECOND FLOOR  
 6 Month Surveillance

DAMAGED ACBM
  -
